**Flood Control Project Maintenance  
Levee Inspections****LMA District Cover Sheet  
Spring 2014 Levee Inspection Results****Reclamation District No. 0150 Merrit Island**

**Flood Control Project Maintenance  
Levee Inspections**

**Spring 2014 Levee Inspection Results**

**Reclamation District No. 0150 Merrit Island**

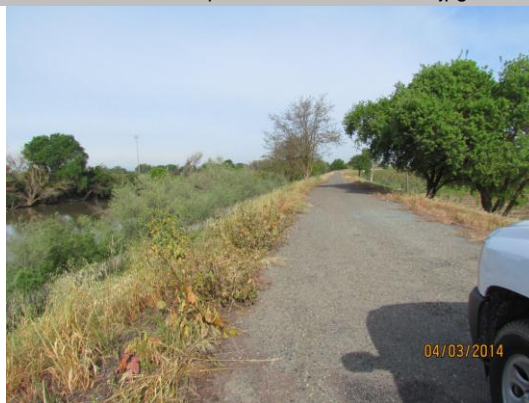
Photo 1 of 1 : pkazi\_s\_20140404\_066.jpg

View of vegetation on the waterside slope of the levee looking upstream.

LM Start	0.04	Rating **	M	Issue No.	1
LM End	0.51	Issue Type +	Ma	Location *	WS
Category	Earthen Levee			GPS Latitude/Longitude	
				Start	End
Item	Vegetation			38.332443 °	38.328222 °
				-121.582769 °	-121.576586 °
DWR ID	DWR_RD0150_01_s _ 2014_1				
Action/Comments					
Control annual grass and weeds on the levee slopes and easements.

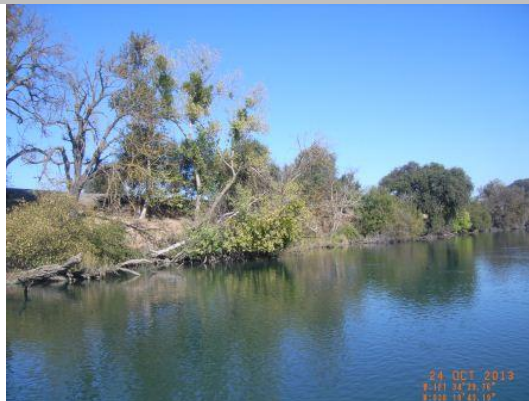
Photo 2 of 2 : USACE2013A\_STR\_28-4\_R\_17.jpg

LM Start	0.44	Rating **	M	Issue No.	2 (cont)
LM End	0.49	Issue Type +	Ma	Location *	WS
Category	Supplemental			GPS Latitude/Longitude	
				Start	End
Item	USACE Erosion Survey			38.328091 °	38.328606 °
				-121.576640 °	-121.577472 °
DWR ID					
Action/Comments					
Inspector Comments: 2013: Old toe repair unraveling. Bridge at upstream end of site. [2013 Site ID: STR 28-4 R]

USACE 2013 Photo #2

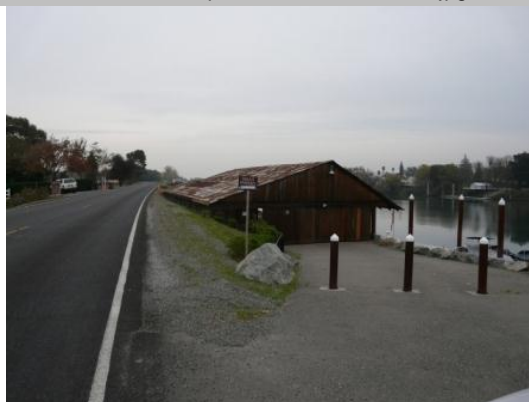
Photo 1 of 1 : pkazi\_s\_20140328\_563.jpg

LM Start	0.16	Rating **	M	Issue No.	49
LM End	0.16	Issue Type +	En	Location *	WS
Category	Earthen Levee			GPS Latitude/Longitude	
				Start	End
Item	Encroachments			38.330047 °	38.330047 °
				-121.574538 °	-121.574538 °
DWR ID	DWR_RD0150_02_s _ 2012_49				
Action/Comments					
Building

Building located on waterside of levee at LM 0.16

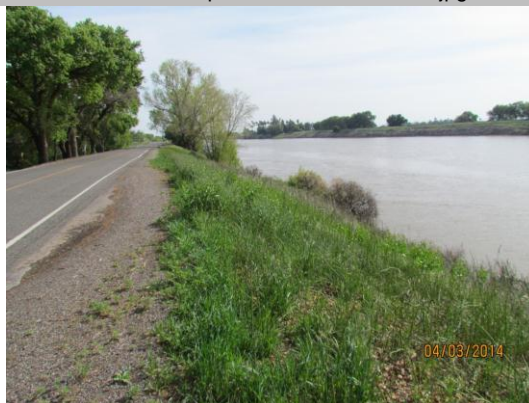
Photo 1 of 1 : pkazi\_s\_20140404\_068.jpg

View of the vegetation on the waterside of the levee looking upstream.

LM Start	0.22	Rating **	M	Issue No.	48
LM End	7.85	Issue Type +	Ma	Location *	WS
Category	Earthen Levee			GPS Latitude/Longitude	
				Start	End
Item	Vegetation			38.330748 °	38.412828 °
				-121.573872 °	-121.522019 °
DWR ID	DWR_RD0150_02_s _ 2014_48				
Action/Comments					
Control annual grass and weeds on the levee slopes and easements.

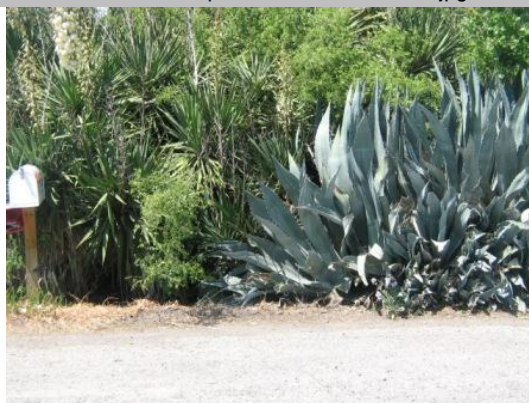
Photo 1 of 1 : pkazi\_s\_20140328\_539.jpg

LM Start	0.25	Rating **	U	Issue No.	4
LM End	0.25	Issue Type +	En	Location *	LS
Category	Earthen Levee			GPS Latitude/Longitude	
				Start	End
Item	Vegetation			38.331035 °	38.331035 °
				-121.573502 °	-121.573502 °
DWR ID	DWR_RD0150_02_s _ 2012_4				
Action/Comments					
Landscaping

Landscaping on landward slope at LM 0.25 blocking view of levee slope.

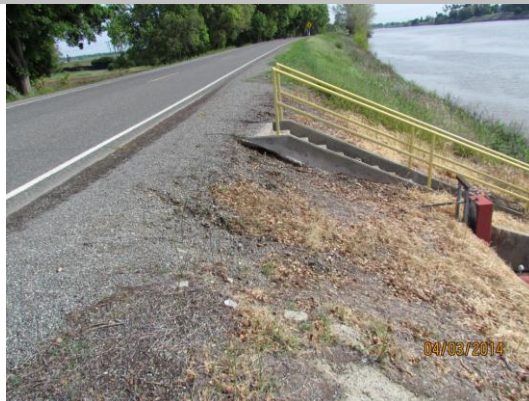
Photo 1 of 2 : pkazi\_s\_20140404\_067.jpg

Updated photo of the slope instability on the waterside of the levee looking upstream during spring 2014 inspection.

LM Start	0.40	Rating **	M	Issue No.	6
LM End	0.40	Issue Type +	Ma	Location *	WS
Category	Earthen Levee			GPS Latitude/Longitude	
				Start	End
Item	Slope Stability			38.332717 °	38.332717 °
				-121.572083 °	-121.572083 °
DWR ID	DWR_RD0150_02_s _ 2012_6				
Action/Comments					
Repair the levee slope damaged by foot traffic and prevent access where possible.

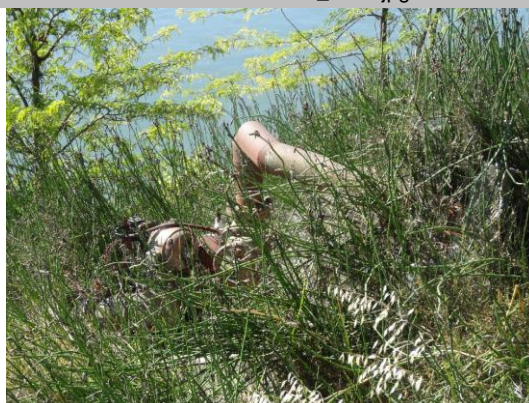
Photo 1 of 1 : UCIP\_2200.jpg

WS view: steel pipe and pump on levee slope. Dense vegetation on waterside.

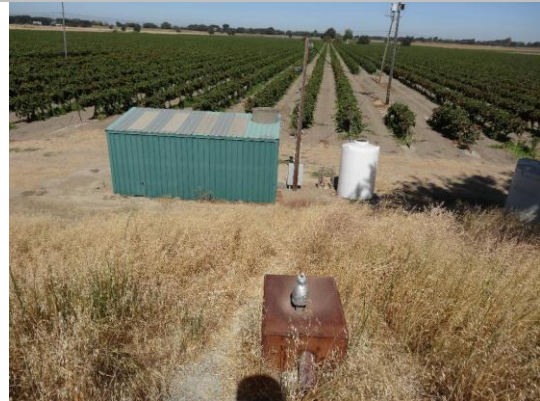
Photo 1 of 1 : UCIP\_2208.jpg

LS view: 10-inch pipe and air vent on levee slope. Concrete standpipe inside water filtration plant.

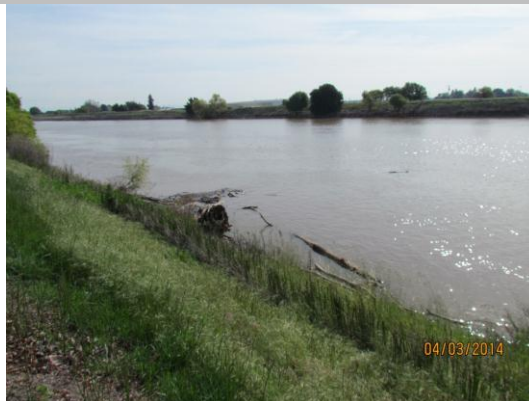
Photo 1 of 2 : pkazi\_s\_20140404\_069.jpg

LM Start	1.00	Rating **	M	Issue No.	18
LM End	1.00	Issue Type +	Ma	Location *	WS
Category	Earthen Levee			GPS Latitude/Longitude	
				Start	End
Item	Encroachments			38.339268 °	38.339268 °
				-121.564839 °	-121.564839 °
DWR ID	DWR_RD0150_02_s _ 2013_18				
Action/Comments					
Tree or limb					
Inspector Comments: Tree trunk was found on the waterside toe of the levee.

Updated picture of the tree trunk on the waterside toe of the levee looking upstream during spring 2014 inspection.

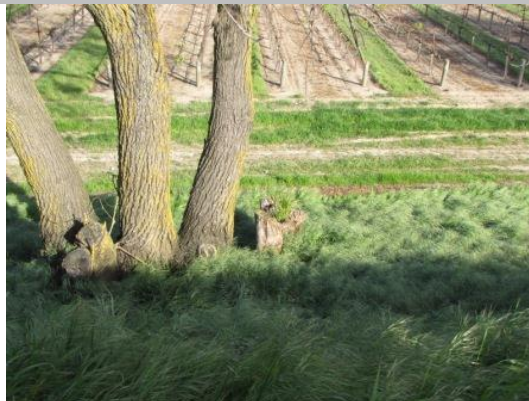
Photo 1 of 1 : pkazi\_s\_20140328\_541.jpg

LM Start	1.16	Rating **	N	Issue No.	8
LM End	1.16	Issue Type +	Ma	Location *	LS
Category	Earthen Levee			GPS Latitude/Longitude	
				Start	End
Item	Trim / Thin Trees			38.340864 °	38.340864 °
				-121.562915 °	-121.562915 °
DWR ID	DWR_RD0150_02_s _ 2012_8				
Action/Comments					
Tree stumps.

View of a tree stump on the landward slope.

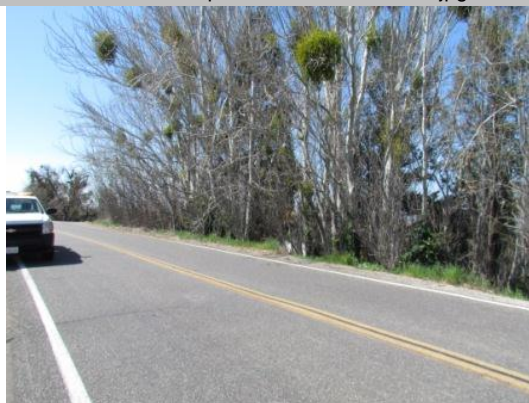
Photo 2 of 2 : pkazi\_s\_20140328\_578.jpg

Landscaping was obstructing the view of the landside slope of the levee looking downstream. This picture was taken during spring 2013 inspection.

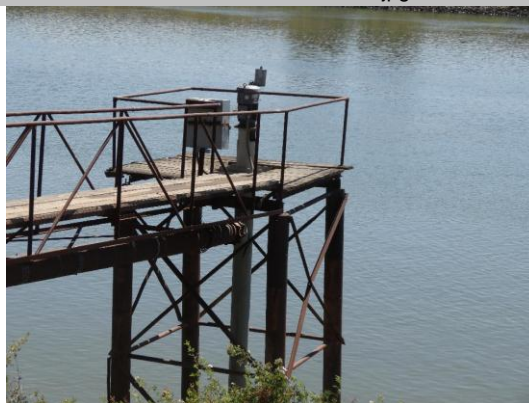
Photo 1 of 1 : UCIP\_2214.jpg

WS view: pipe & pump on piling structure in the stream.

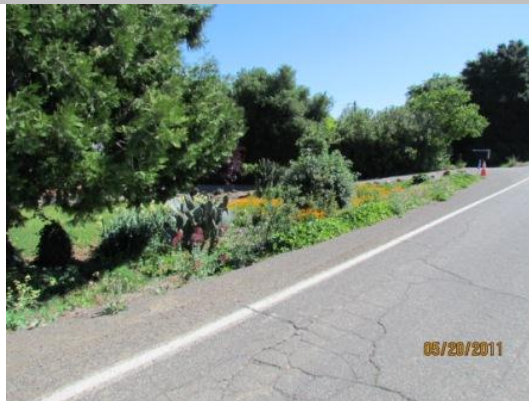
Photo 1 of 1 : pkazi\_s\_20140328\_576.jpg

Landscaping was found on the landside of the levee. The picture was taken from the crown looking upstream.

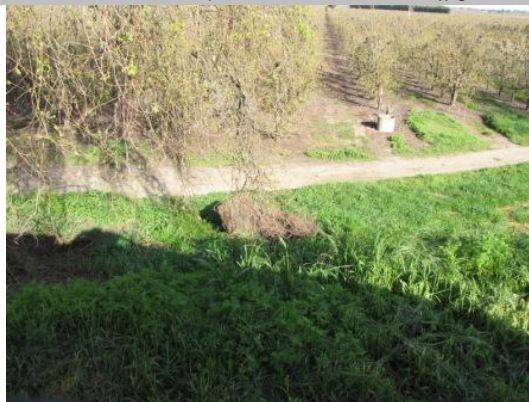
Photo 1 of 1 : pkazi\_s\_20140328\_546.jpg

LM Start	2.80	Rating **	N	Issue No.	14
LM End	2.80	Issue Type +	Ma	Location *	LS
Category	Earthen Levee			GPS Latitude/Longitude	
				Start	End
Item	Trim / Thin Trees			38.350041 °	38.350041 °
				-121.536853 °	-121.536853 °
DWR ID	DWR_RD0150_02_s _ 2012_14				
Action/Comments					
Tree stumps.

View of a tree stump on the landward slope.

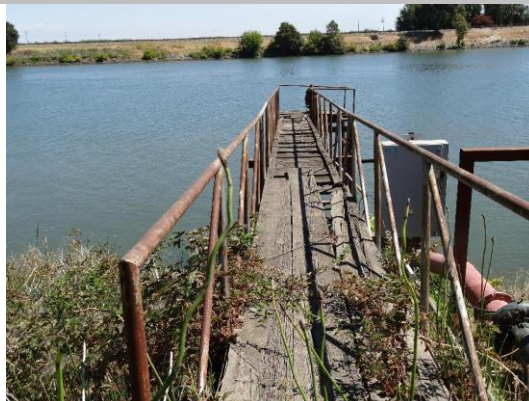
Photo 1 of 1 : UCIP\_2307.jpg

WS view: abandoned walkway on piling structure in the stream.

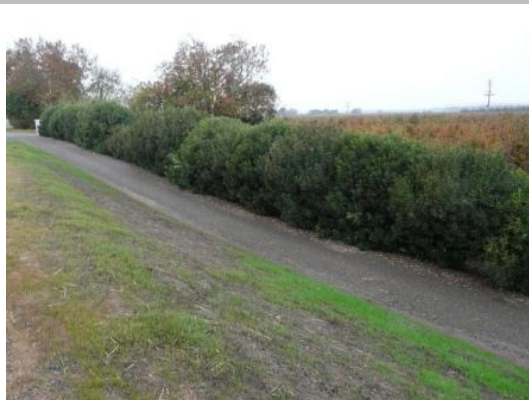
Photo 1 of 1 : pkazi\_s\_20140328\_575.jpg

Landscaping providing a screen for a residence on landside of levee from LM 3.02 to LM 3.06

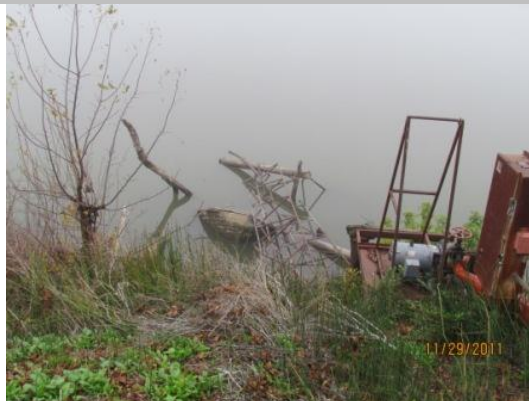
Photo 3 of 6 : pkazi\_s\_20140328\_582.jpg

View of the erosion site, and broken pump support along with a boat on the waterside of the levee. The picture was taken from the crown looking towards the toe of the levee during fall 2011 inspection.

LM Start	3.29	Rating **	M	Issue No.	961 (cont)	
LM End	3.29	Issue Type +	Ma	Location *	WS	
Category	Earthen Levee			GPS Latitude/Longitude		
				Start	End	
Item	Erosion / Bank Caving			38.355321 °	38.355321 °	
				-121.530902 °	-121.530902 °	
DWR ID	DWR_RD0150_02_s _ 2012_961					
Action/Comments						
Schedule repair of erosion site prior to the next inspection.

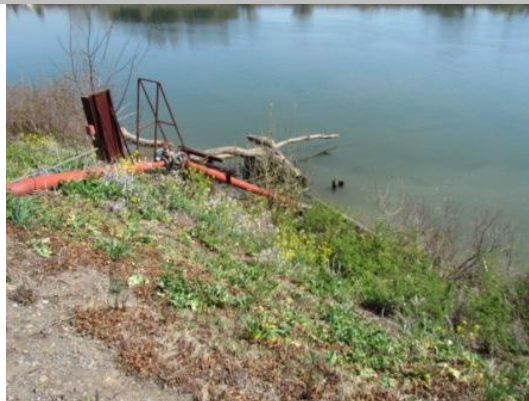
Photo 5 of 6 : pkazi\_s\_20140328\_584.jpg

View of the erosion on the waterside slope of the levee looking upstream during spring 2013 inspection.

LM Start	3.29	Rating **	M	Issue No.	961 (cont)	
LM End	3.29	Issue Type +	Ma	Location *	WS	
Category	Earthen Levee			GPS Latitude/Longitude		
				Start	End	
Item	Erosion / Bank Caving			38.355321 °	38.355321 °	
				-121.530902 °	-121.530902 °	
DWR ID	DWR_RD0150_02_s _ 2012_961					
Action/Comments						
Schedule repair of erosion site prior to the next inspection.

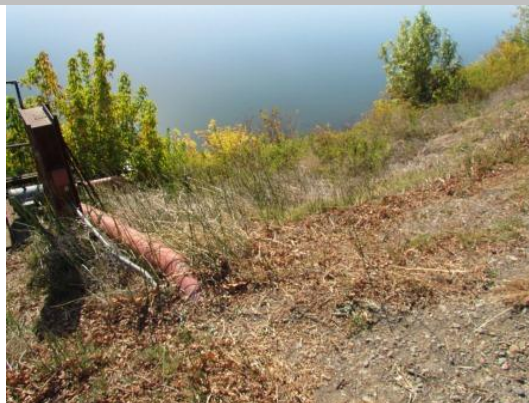
Photo 6 of 6 : pkazi\_s\_20140328\_585.jpg

View of the erosion on the waterside slope of the levee near the pipe looking downstream. This picture was taken during the fall 2013 inspection.

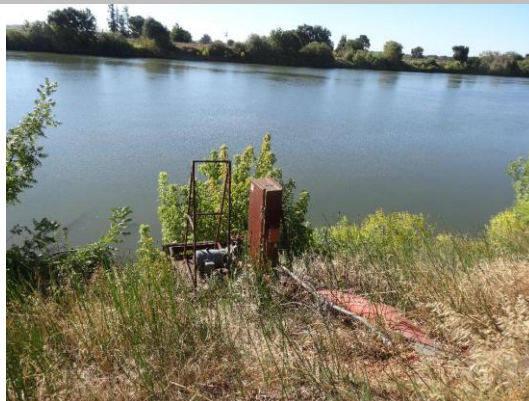
Photo 1 of 1 : UCIP\_2311.jpg

WS view: pipe, conduit and pump on levee slope.

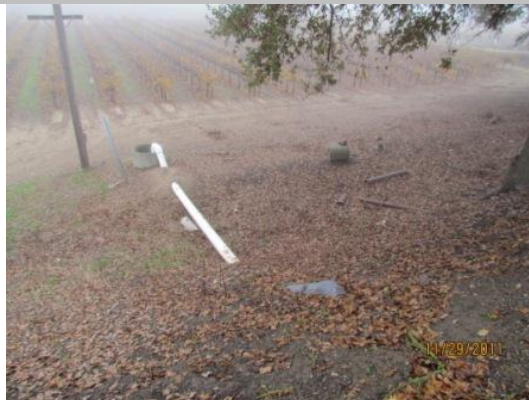
Photo 1 of 2 : pkazi\_s\_20140328\_547.jpg

LM Start	3.56	Rating **	A/W	Issue No.	15
LM End	3.56	Issue Type +	En	Location *	CR
Category	Earthen Levee			GPS Latitude/Longitude	
				Start	End
Item	Encroachments			38.358152 °	38.358152 °
				-121.527579 °	-121.527579 °
DWR ID	DWR_RD0150_02_s _ 2012_15				
Action/Comments					
Pipe					
Inspector Comments: PVC pipe is sleeving through an old steel pipe.					
The steel pipe appears to be fine for now, but we should keep an eye on it.

A PVC pipe was used under the levee crown for irrigation purpose. The picture was taken from the crown looking downstream.

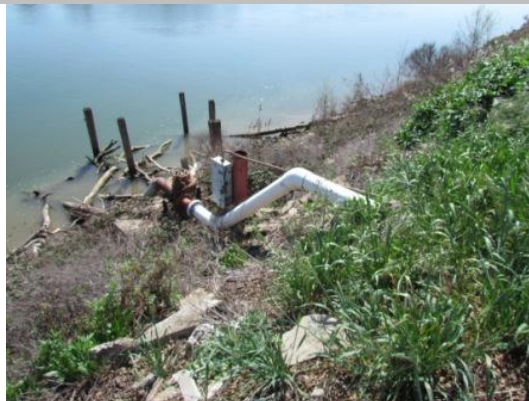
Photo 2 of 2 : pkazi\_s\_20140328\_548.jpg

LM Start	3.56	Rating **	A/W	Issue No.	15 (cont)	
LM End	3.56	Issue Type +	En	Location *	CR	
Category	Earthen Levee			GPS Latitude/Longitude		
				Start	End	
Item	Encroachments			38.358152 °	38.358152 °	
				-121.527579 °	-121.527579 °	
DWR ID	DWR_RD0150_02_s _ 2012_15					
Action/Comments						
Pipe Inspector Comments: PVC pipe is sleeving through an old steel pipe. The steel pipe appears to be fine for now, but we should keep an eye on it.

A PVC pipe was used to pump the water from waterside of the levee. It appeared that the PVC pipe was penetrating through a corroded steel casing through the levee crown. The picture was taken from the crown of the levee looking upstream during spring 2013 inspection.

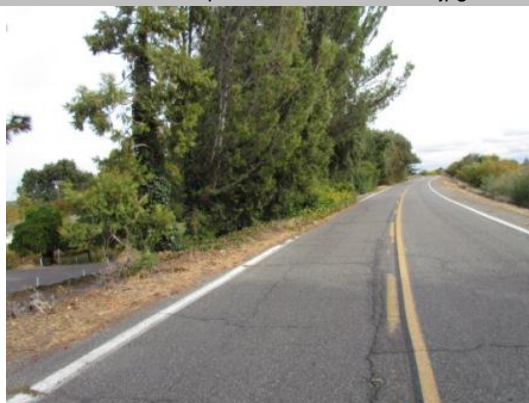
Photo 1 of 1 : pkazi\_s\_20140328\_574.jpg

LM Start	3.60	Rating **	U	Issue No.	82
LM End	3.73	Issue Type +	En	Location *	LS
Category	Earthen Levee			GPS Latitude/Longitude	
				Start	End
Item	Vegetation			38.358565 °	38.359729 °
				-121.527153 °	-121.525345 °
DWR ID	DWR_RD0150_02_s _ 2012_82				
Action/Comments					
Landscaping

Landscaping was blocking the visibility on the landside of the levee looking upstream.

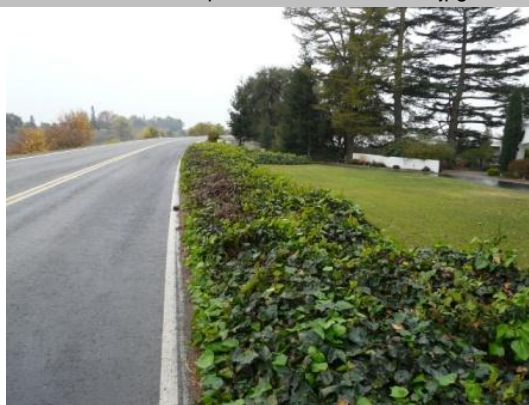
Photo 1 of 1 : pkazi\_s\_20140328\_573.jpg

LM Start	3.90	Rating **	M	Issue No.	80
LM End	3.93	Issue Type +	En	Location *	LS
Category	Earthen Levee			GPS Latitude/Longitude	
				Start	End
Item	Vegetation			38.361419 °	38.361752 °
				-121.523225 °	-121.522974 °
DWR ID	DWR_RD0150_02_s _ 2012_80				
Action/Comments					
Landscaping

Landscaping in front of a residence on landside of levee from LM 3.90 to LM 3.93. The levee in this location is greater than 100' wide.

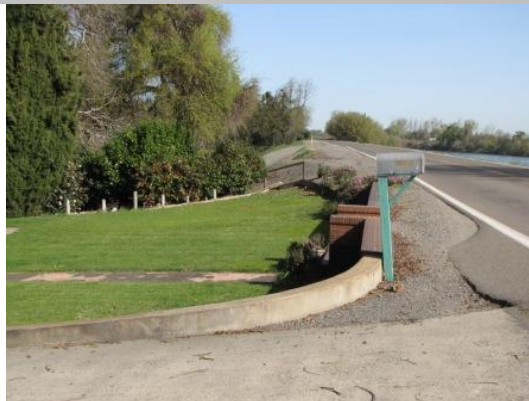
Photo 1 of 1 : pkazi\_s\_20140328\_550.jpg

LM Start	4.15	Rating **	M	Issue No.	20
LM End	4.16	Issue Type +	En	Location *	LS
Category	Earthen Levee			GPS Latitude/Longitude	
				Start	End
Item	Encroachments			38.364854 °	38.365104 °
				-121.522378 °	-121.522365 °
DWR ID	DWR_RD0150_02_s _ 2012_20				
Action/Comments					
Building					
Inspector Comments: 3' retaining wall at the landward shoulder.

View of a retaining wall on the landward slope looking upstream.

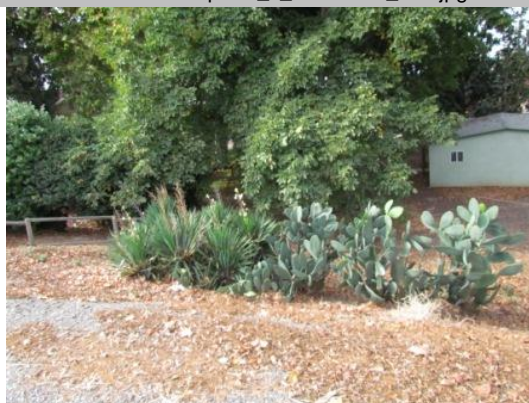
Photo 1 of 1 : pkazi\_s\_20140328\_579.jpg

LM Start	4.17	Rating **	M	Issue No.	953
LM End	4.17	Issue Type +	En	Location *	LS
Category	Earthen Levee			GPS Latitude/Longitude	
				Start	End
Item	Vegetation			38.365162 °	38.365162 °
				-121.522365 °	-121.522365 °
DWR ID	DWR_RD0150_02_s _ 2012_953				
Action/Comments					
Landscaping

View of cacti on the landside of the levee looking from the crown.

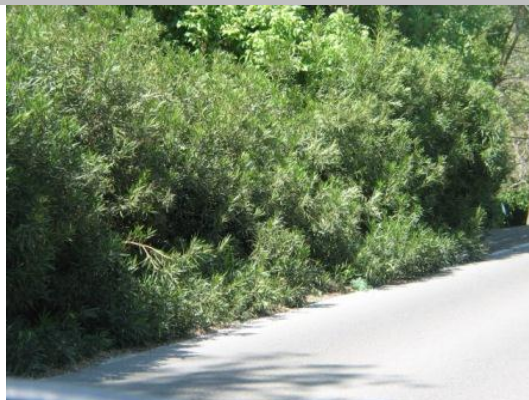
Photo 1 of 1 : pkazi\_s\_20140328\_552.jpg

LM Start	4.33	Rating **	U	Issue No.	24
LM End	4.35	Issue Type +	En	Location *	LS
Category	Earthen Levee			GPS Latitude/Longitude	
				Start	End
Item	Vegetation			38.367442 °	38.367740 °
				-121.522427 °	-121.522495 °
DWR ID	DWR_RD0150_02_s _ 2012_24				
Action/Comments					
Landscaping

Landscaping (Oleander) on landward slope from 4.33 to 4.35

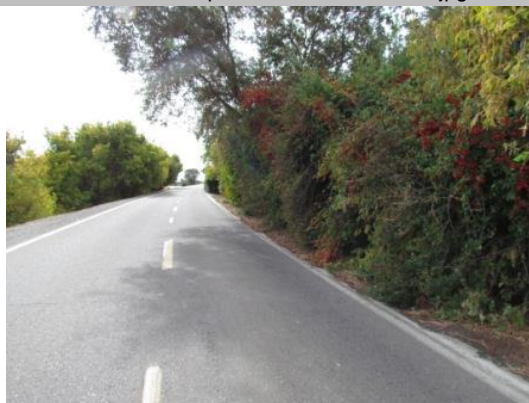
Photo 1 of 1 : pkazi\_s\_20140328\_572.jpg

LM Start	4.37	Rating **	U	Issue No.	79
LM End	4.41	Issue Type +	En	Location *	LS
Category	Earthen Levee			GPS Latitude/Longitude	
				Start	End
Item	Vegetation			38.368036 °	38.368540 °
				-121.522611 °	-121.522729 °
DWR ID	DWR_RD0150_02_s _ 2012_79				
Action/Comments					
Landscaping

Trees were obstructing the views on the landside slope of the levee looking downstream.

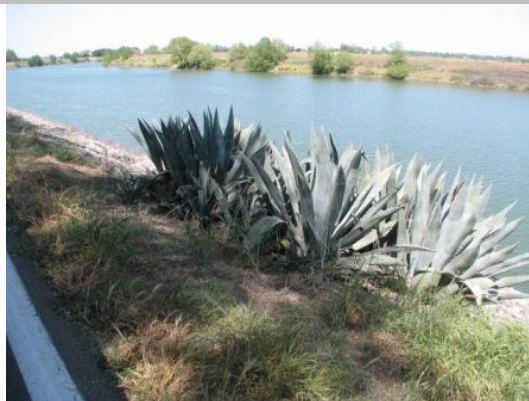
Photo 1 of 1 : pkazi\_s\_20140328\_554.jpg

LM Start	4.76	Rating **	M	Issue No.	28
LM End	4.76	Issue Type +	Ma	Location *	WS
Category	Earthen Levee			GPS Latitude/Longitude	
				Start	End
Item	Vegetation			38.373485 °	38.373485 °
				-121.523963 °	-121.523963 °
DWR ID	DWR_RD0150_02_s _ 2012_28				
Action/Comments					
Remove the wild growth other than native grasses from the levee slopes.

Century plant on waterward slope at LM 4.76

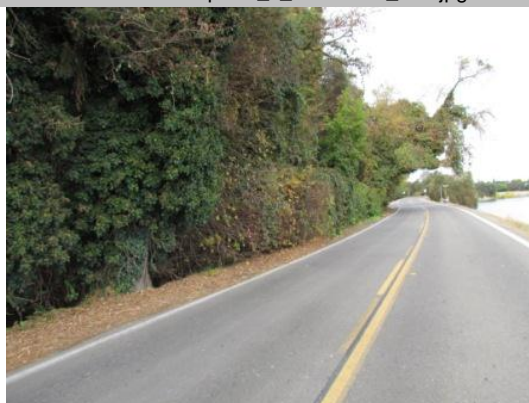
Photo 1 of 1 : pkazi\_s\_20140328\_571.jpg

LM Start	4.78	Rating **	U	Issue No.	76
LM End	4.79	Issue Type +	En	Location *	LS
Category	Earthen Levee			GPS Latitude/Longitude	
				Start	End
Item	Vegetation			38.373688 °	38.373970 °
				-121.524280 °	-121.524403 °
DWR ID	DWR_RD0150_02_s _ 2012_76				
Action/Comments					
Landscaping

Trees were obstructing the view of the landside slope of the levee looking upstream.

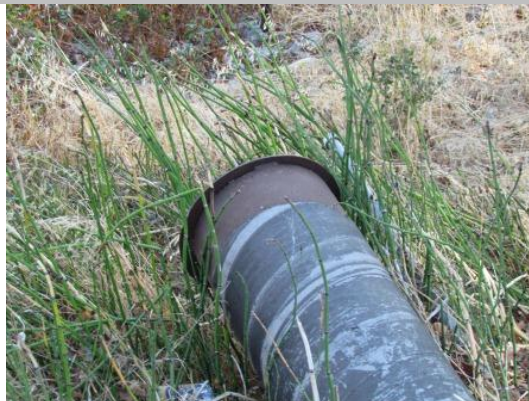
Photo 1 of 1 : pkazi\_s\_20140328\_569.jpg

LM Start	4.93	Rating **	M	Issue No.	69
LM End	4.93	Issue Type +	Ma	Location *	WS
Category	Earthen Levee			GPS Latitude/Longitude	
				Start	End
Item	Encroachments			38.375731 °	38.375731 °
				-121.525245 °	-121.525245 °
DWR ID	DWR_RD0150_02_f_2013_69				
Action/Comments					
Pipe Inspector Comments: The pipe cover is not a water tight connection. During high water, water may leak through the pipe and get into the landside.

The pipe cover doesn't appear to be water tight on the waterside slope of the levee. The picture was taken from the crown looking towards the toe of the levee during fall 2013 inspection.

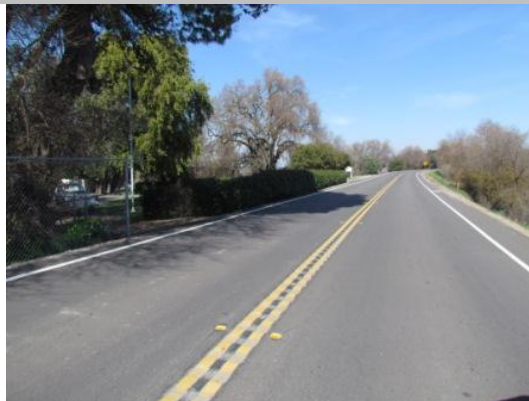
Photo 1 of 1 : pkazi\_s\_20140328\_555.jpg

LM Start	5.14	Rating **	M	Issue No.	30
LM End	5.17	Issue Type +	En	Location *	LS
Category	Earthen Levee			GPS Latitude/Longitude	
				Start	End
Item	Vegetation			38.378715 °	38.379052 °
				-121.525458 °	-121.525341 °
DWR ID	DWR_RD0150_02_s _ 2012_30				
Action/Comments					
Landscaping

Landscaping was found on the landside shoulder of the levee looking upstream.

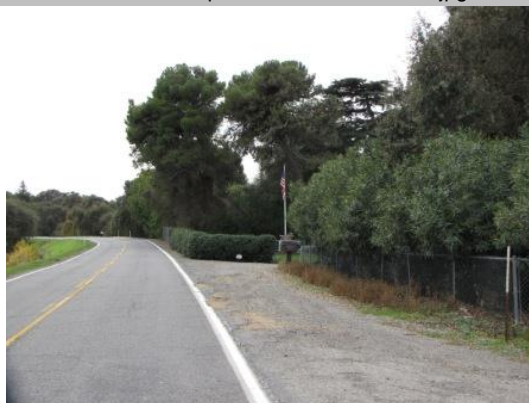
Photo 1 of 1 : pkazi\_s\_20140328\_570.jpg

LM Start	5.17	Rating **	M	Issue No.	75
LM End	5.22	Issue Type +	En	Location *	LS
Category	Earthen Levee			GPS Latitude/Longitude	
				Start	End
Item	Vegetation			38.379054 °	38.379769 °
				-121.525341 °	-121.525024 °
DWR ID	DWR_RD0150_02_s _ 2012_75				
Action/Comments					
Landscaping

View of landscaping along the landward shoulder and slope looking downstream.

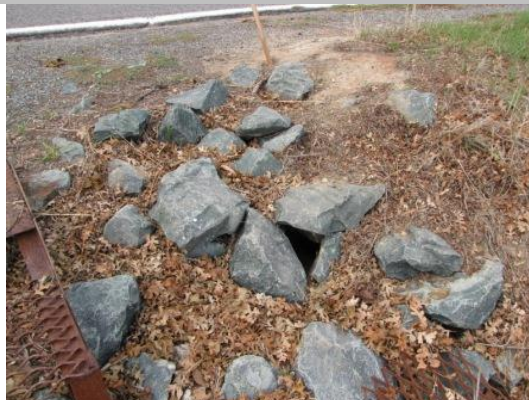
Photo 1 of 1 : pkazi\_s\_20140328\_588.jpg

LM Start	5.33	Rating **	M	Issue No.	976
LM End	5.33	Issue Type +	Ma	Location *	WS
Category	Earthen Levee			GPS Latitude/Longitude	
				Start	End
Item	Slope Stability			38.381126 °	38.381126 °
				-121.524208 °	-121.524208 °
DWR ID	DWR_RD0150_02_s _ 2012_976				
Action/Comments					
Repair slope instability. Inspector Comments: Cavity located under rock rip rap on waterward slope at the shoulder over an irrigation pipe.

View of rock placed on a pipe penetration on the waterward slope.  
Cavities can be seen under the rocks.

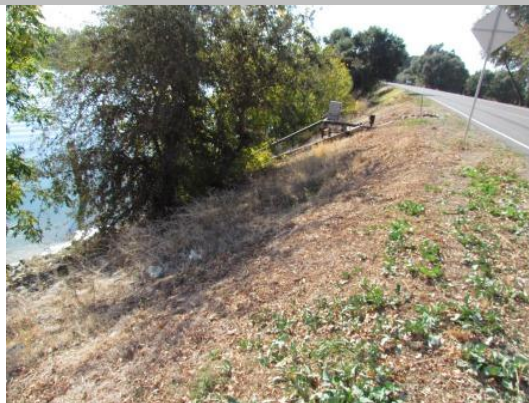
Photo 2 of 2 : pkazi\_s\_20140328\_587.jpg

LM Start	<b>5.33</b>	Rating **	M	Issue No.	<b>975 (cont)</b>
LM End	<b>5.33</b>	Issue Type +	Ma	Location *	WS

View of minor slope instability on the waterside slope of the levee looking downstream during fall 2013 inspection.

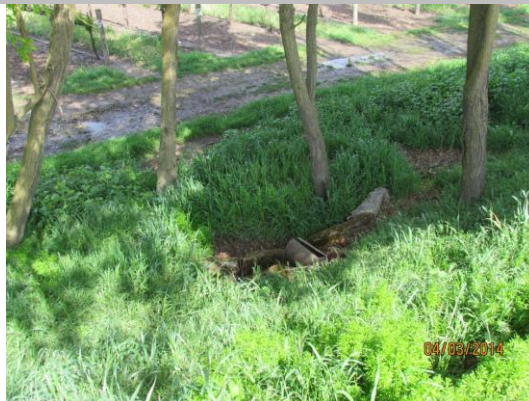
Photo 1 of 1 : pkazi\_s\_20140404\_070.jpg

LM Start	5.34	Rating **	M	Issue No.	51
LM End	5.34	Issue Type +	En	Location *	LS
Category	Earthen Levee			GPS Latitude/Longitude	
				Start	End
Item	Encroachments			38.381233 °	38.381233 °
				-121.524078 °	-121.524078 °
DWR ID	DWR_RD0150_02_s _ 2014_51				
Action/Comments					
Pipe

View of a damaged pipe on the landside toe of the levee looking upstream.

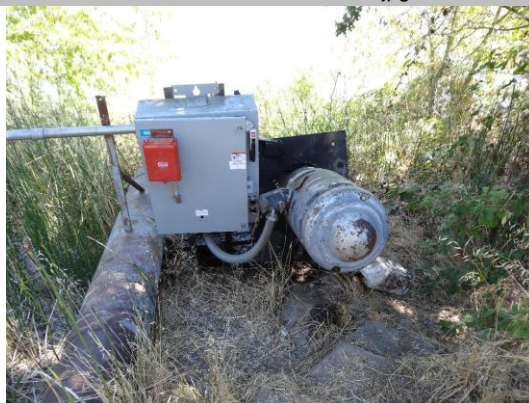
Photo 1 of 1 : UCIP\_2325.jpg

UCIP Comments: - slope erosion due leaky siphon breaker at CMP rise/leaky pipe and pump service pole on LS electric conduit on WS

WS view: steel pipe and slant pump on levee slope.

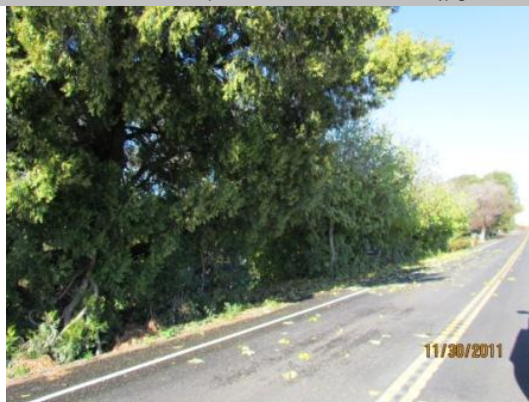
Photo 1 of 1 : pkazi\_s\_20140328\_556.jpg

LM Start	6.46	Rating **	M	Issue No.	31
LM End	6.46	Issue Type +	En	Location *	LS
Category	Earthen Levee			GPS Latitude/Longitude	
				Start	End
Item	Vegetation			38.394416 °	38.394416 °
				-121.514590 °	-121.514590 °
DWR ID	DWR_RD0150_02_s _ 2012_31				
Action/Comments					
Landscaping

Trees need to be trimmed on the landside of the levee looking upstream.

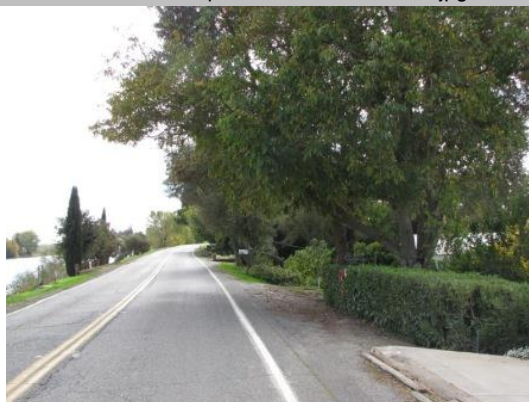
Photo 1 of 1 : pkazi\_s\_20140328\_568.jpg

LM Start	6.50	Rating **	M	Issue No.	65
LM End	6.57	Issue Type +	En	Location *	LS
Category	Earthen Levee			GPS Latitude/Longitude	
				Start	End
Item	Vegetation			38.394935 °	38.395931 °
				-121.514597 °	-121.514604 °
DWR ID	DWR_RD0150_02_s _ 2012_65				
Action/Comments					
Landscaping

View of landscaping along the waterward shoulder and slope looking downstream.

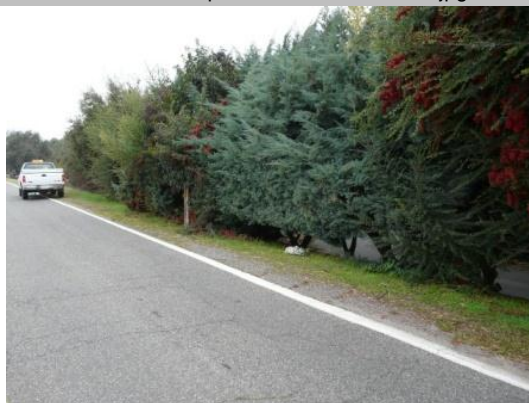
Photo 1 of 1 : pkazi\_s\_20140328\_567.jpg

LM Start	6.67	Rating **	U	Issue No.	64
LM End	6.72	Issue Type +	En	Location *	LS
Category	Earthen Levee			GPS Latitude/Longitude	
				Start	End
Item	Vegetation			38.397411 °	38.398033 °
				-121.514681 °	-121.514753 °
DWR ID	DWR_RD0150_02_s _ 2012_64				
Action/Comments					
Landscaping

Landscaping providing a screen for a residence on landside of levee from LM 6.68 to LM 6.72

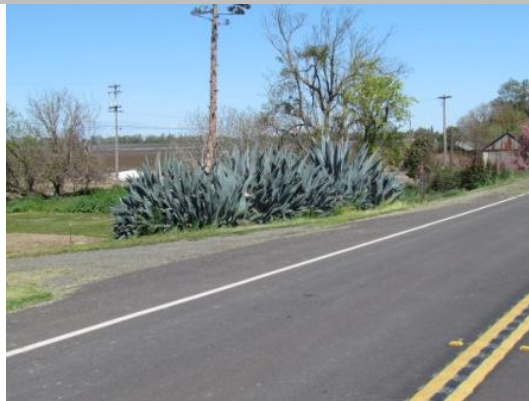
Photo 1 of 1 : pkazi\_s\_20140328\_562.jpg

LM Start	6.75	Rating **	M	Issue No.	43
LM End	6.75	Issue Type +	En	Location *	LS
Category	Earthen Levee			GPS Latitude/Longitude	
				Start	End
Item	Vegetation			38.398456 °	38.398456 °
				-121.514735 °	-121.514735 °
DWR ID	DWR_RD0150_02_s _ 2012_43				
Action/Comments					
Landscaping					
Inspector Comments: Century plant on landside of the levee.

Century plants were found on the landside of the levee looking upstream.

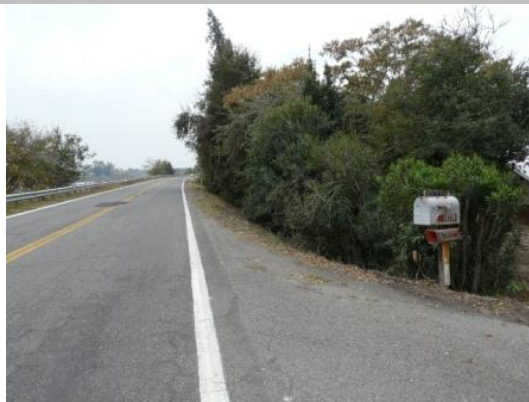
Photo 1 of 1 : pkazi\_s\_20140328\_566.jpg

LM Start	6.93	Rating **	U	Issue No.	60
LM End	7.05	Issue Type +	En	Location *	LS
Category	Earthen Levee			GPS Latitude/Longitude	
				Start	End
Item	Vegetation			38.400936 °	38.402613 °
				-121.515173 °	-121.515863 °
DWR ID	DWR_RD0150_02_s _ 2012_60				
Action/Comments					
Landscaping

Landscaping providing a screen for a residence on the landside of levee from LM 6.93 to LM 7.05

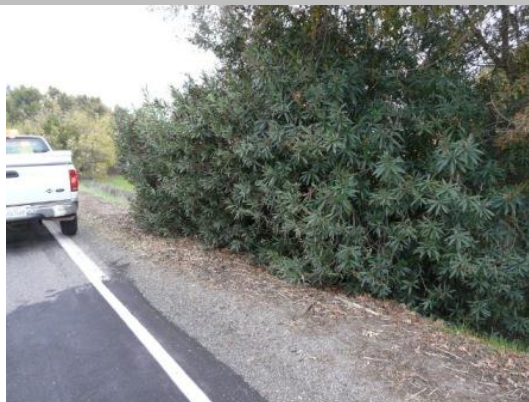
Photo 1 of 1 : pkazi\_s\_20140328\_565.jpg

LM Start	7.12	Rating **	M	Issue No.	58
LM End	7.12	Issue Type +	En	Location *	LS
Category	Earthen Levee			GPS Latitude/Longitude	
				Start	End
Item	Vegetation			38.403631 °	38.403631 °
				-121.516299 °	-121.516299 °
DWR ID	DWR_RD0150_02_s _ 2012_58				
Action/Comments					
Landscaping

Landscaping providing a screen for a residence on landside of levee at LM 7.12

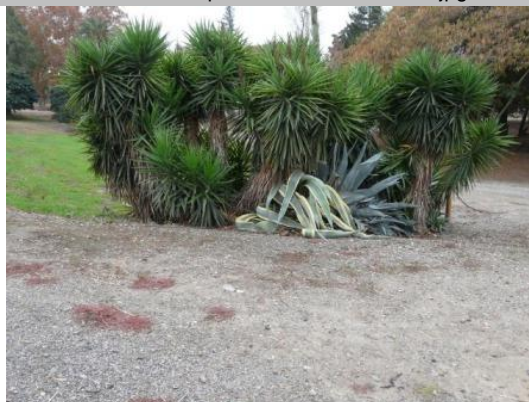
Photo 1 of 1 : pkazi\_s\_20140328\_564.jpg

LM Start	7.92	Rating **	M	Issue No.	56
LM End	7.92	Issue Type +	En	Location *	LS
Category	Earthen Levee			GPS Latitude/Longitude	
				Start	End
Item	Vegetation			38.413705 °	38.413705 °
				-121.522806 °	-121.522806 °
DWR ID	DWR_RD0150_02_s _ 2012_56				
Action/Comments					
Landscaping

Landscaping on landside of levee at LM 7.92

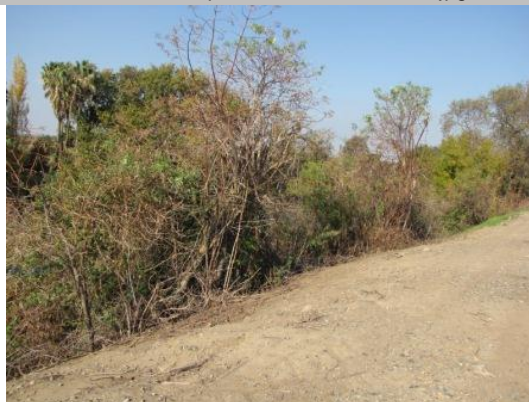
Photo 1 of 1 : pkazi\_s\_20140328\_708.jpg

LM Start	0.11	Rating **	A/W	Issue No.	936
LM End	0.11	Issue Type +	Ma	Location *	WS
Category	Earthen Levee			GPS Latitude/Longitude	
				Start	End
Item	Vegetation			38.334233 °	38.334233 °
				-121.583414 °	-121.583414 °
DWR ID	DWR_RD0150_03_s_2012_936				
Action/Comments					
Elderberries are blocking visibility and flood fight capability.

View of elderberry bush within 20 feet of shoulder blocking visibility and access.

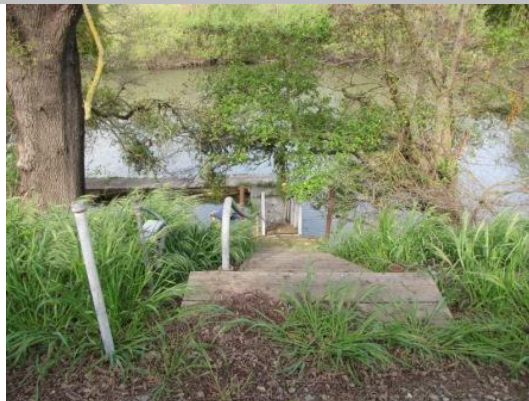
Photo 1 of 1 : pkazi\_s\_20140328\_609.jpg

LM Start	0.36	Rating **	M	Issue No.	3
LM End	0.36	Issue Type +	En	Location *	WS
Category	Earthen Levee			GPS Latitude/Longitude	
				Start	End
Item	Encroachments			38.337442 °	38.337442 °
				-121.581628 °	-121.581628 °
DWR ID	DWR_RD0150_03_s _ 2012_3				
Action/Comments					
Building Inspector Comments: Steps, water, electricity, and dock on waterward slope.

View of steps, a dock, and associated utilities on the waterward slope.

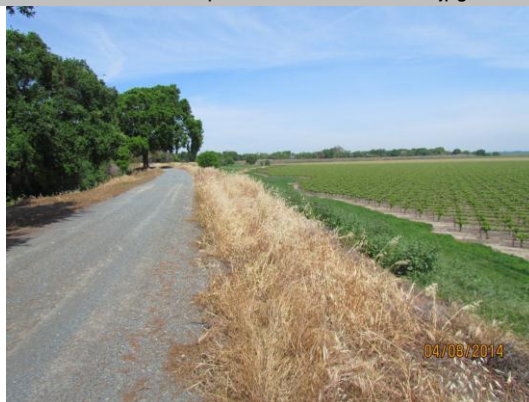
Photo 1 of 1 : pkazi\_s\_20140408\_079.jpg

LM Start	0.67	Rating **	M	Issue No.	81
LM End	1.04	Issue Type +	Ma	Location *	LS
Category	Earthen Levee			GPS Latitude/Longitude	
				Start	End
Item	Vegetation			38.341839 °	38.346783 °
				-121.580437 °	-121.578928 °
DWR ID	DWR_RD0150_03_s_2014_81				
Action/Comments					
Control annual grass and weeds on the levee slopes and easements.

View of vegetation on the landside of the levee looking upstream.

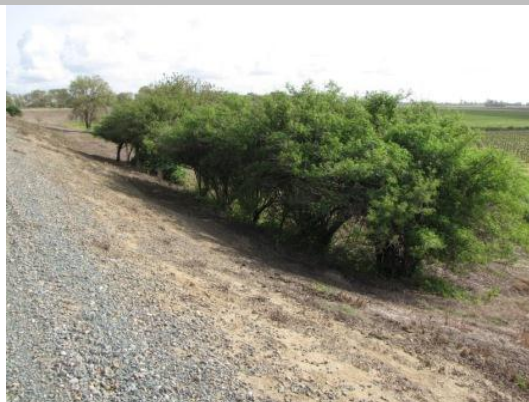
Photo 1 of 1 : pkazi\_s\_20140328\_612.jpg

LM Start	0.92	Rating **	A/W	Issue No.	5
LM End	0.95	Issue Type +	Ma	Location *	LS
Category	Earthen Levee			GPS Latitude/Longitude	
				Start	End
Item	Vegetation			38.345293 °	38.345634 °
				-121.579769 °	-121.579574 °
DWR ID	DWR_RD0150_03_s_2012_5				
Action/Comments					
Elderberries are blocking visibility and flood fight capability.

View of elderberries on the landward slope blocking visibility and access.

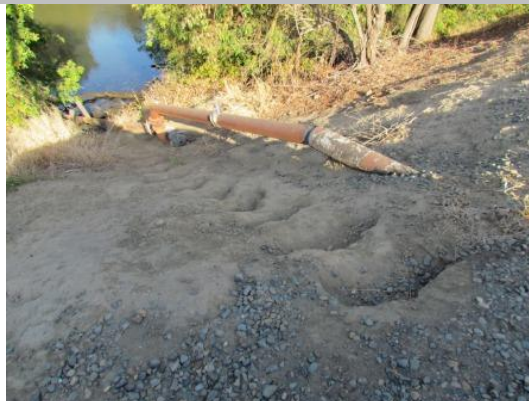
Photo 2 of 2 : pkazi\_s\_20140328\_649.jpg

LM Start	1.82	Rating **	M	Issue No.	50 (cont)
LM End	1.82	Issue Type +	Ma	Location *	WS
Category	Earthen Levee			GPS Latitude/Longitude	
				Start	End
Item	Erosion / Bank Caving			38.353249 °	38.353249 °
				-121.572848 °	-121.572848 °
DWR ID	DWR_RD0150_03_s _ 2012_50				
Action/Comments					
Note and monitor erosion site.					
Inspector Comments: Erosion appeared under the pipe.

Steps were dug next to the pipe and also erosion was found near the vicinity of the pipe on the waterside slope of the levee looking upstream during fall 2013 inspection.

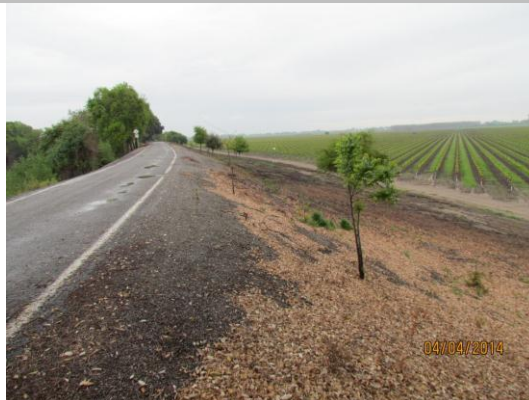
Photo 1 of 5 : pkazi\_s\_20140404\_071.jpg

LM Start	2.34	Rating **	M	Issue No.	78
LM End	2.34	Issue Type +	En	Location *	LS
Category	Earthen Levee			GPS Latitude/Longitude	
				Start	End
Item	Encroachments			38.354286 °	38.354286 °
				-121.564494 °	-121.564494 °
DWR ID	DWR_RD0150_03_s _ 2012_78				
Action/Comments					
Tree or limb					
Inspector Comments: New tree was planted on the landside slope.

View of the newly planted tree on the landside slope of the levee during spring 2014 inspection.

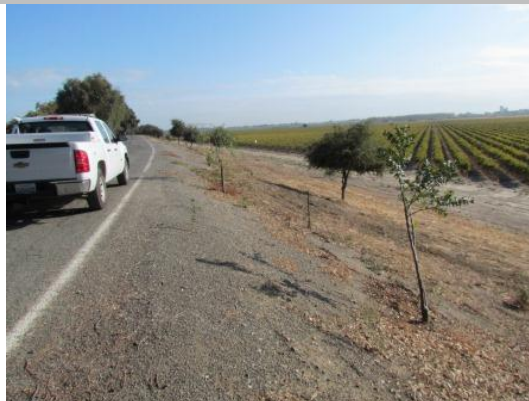
Photo 2 of 5 : pkazi\_s\_20140328\_684.jpg

Several newly planted tree were found on the landside slope of the levee looking upstream during the fall 2013 inspection.

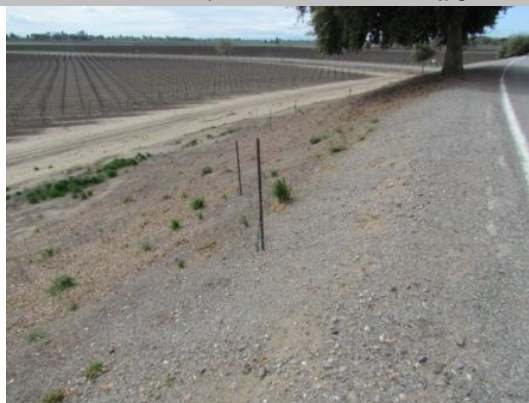
Photo 4 of 5 : pkazi\_s\_20140328\_682.jpg

New tree was planted on the landside of the levee looking downstream.

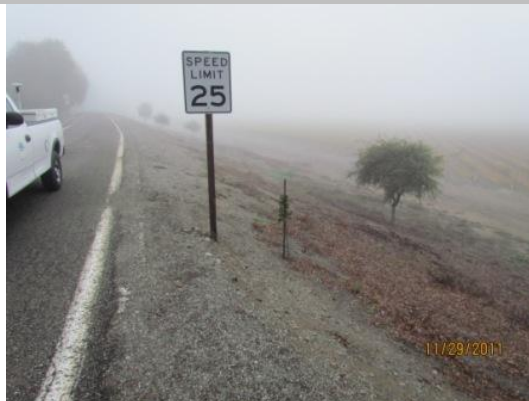
Photo 5 of 5 : pkazi\_s\_20140328\_681.jpg

New tree has been planted on the landside slope of the levee looking upstream.

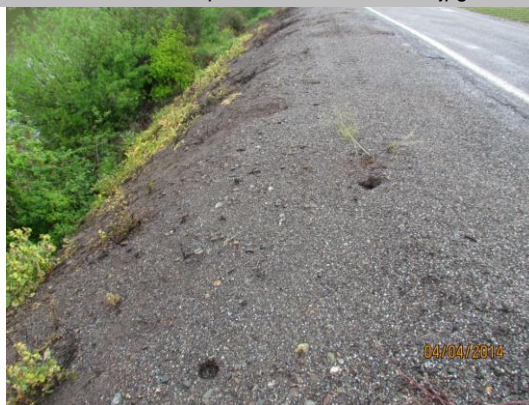
Photo 1 of 1 : pkazi\_s\_20140404\_072.jpg

View of rodent holes on the waterside of the levee looking upstream.

LM Start	2.46	Rating **	M	Issue No.	53
LM End	2.46	Issue Type +	Ma	Location *	WS
Category	Earthen Levee			GPS Latitude/Longitude	
				Start	End
Item	Animal Control			38.355272 °	38.355272 °
				-121.563083 °	-121.563083 °
DWR ID	DWR_RD0150_03_s _ 2014_53				
Action/Comments					
No rodents visible, but rodent burrows visible; need to backfill and compact or grout burrows.

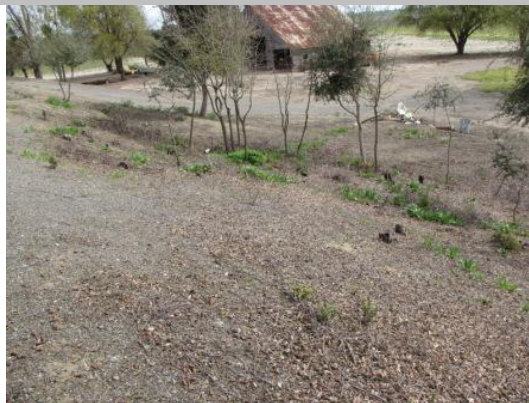
Photo 1 of 1 : pkazi\_s\_20140328\_615.jpg

LM Start	2.60	Rating **	N	Issue No.	11
LM End	2.60	Issue Type +	Ma	Location *	LS
Category	Earthen Levee			GPS Latitude/Longitude	
				Start	End
Item	Trim / Thin Trees			38.356853 °	38.356853 °
				-121.561565 °	-121.561565 °
DWR ID	DWR_RD0150_03_s _ 2012_11				
Action/Comments					
Tree stumps.

View of tree stumps on the landward slope.

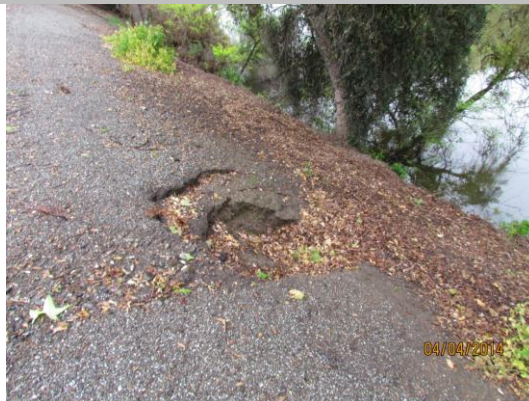
Photo 1 of 2 : pkazi\_s\_20140404\_073.jpg

Updated picture of the erosion on the waterside slope of the levee during spring 2014 inspection.

LM Start	2.86	Rating **	M	Issue No.	35
LM End	2.86	Issue Type +	Ma	Location *	WS
Category	Earthen Levee			GPS Latitude/Longitude	
				Start	End
Item	Erosion / Bank Caving			38.360432 °	38.360432 °
				-121.561644 °	-121.561644 °
DWR ID	DWR_RD0150_03_s_2013_35				
Action/Comments					
Schedule repair of erosion site prior to the next inspection.

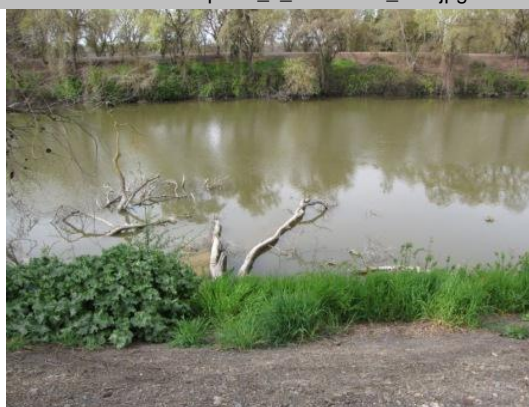
Photo 1 of 1 : pkazi\_s\_20140328\_622.jpg

LM Start	2.87	Rating **	N	Issue No.	17
LM End	2.87	Issue Type +	Ma	Location *	WS
Category	Earthen Levee			GPS Latitude/Longitude	
				Start	End
Item	Trim / Thin Trees			38.360621 °	38.360621 °
				-121.561762 °	-121.561762 °
DWR ID	DWR_RD0150_03_s _ 2012_17				
Action/Comments					
Tree stumps.

View of tree stumps on the waterward slope.

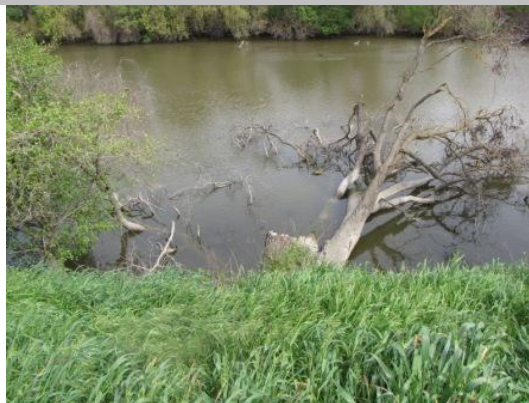
Photo 1 of 1 : pkazi\_s\_20140328\_623.jpg

LM Start	3.21	Rating **	N	Issue No.	20
LM End	3.21	Issue Type +	Ma	Location *	WS
Category	Earthen Levee			GPS Latitude/Longitude	
				Start	End
Item	Trim / Thin Trees			38.363658 °	38.363658 °
				-121.559583 °	-121.559583 °
DWR ID	DWR_RD0150_03_s _ 2012_20				
Action/Comments					
Tree stumps.

View of tree stumps on the waterward slope.

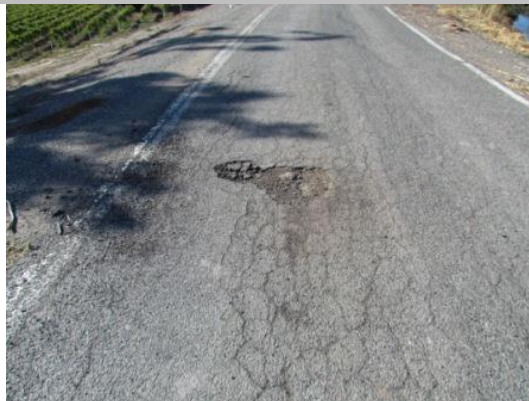
Photo 1 of 1 : pkazi\_s\_20140328\_690.jpg

Crown depression was found on the access road looking downstream.

LM Start	3.31	Rating **	M	Issue No.	91
LM End	3.31	Issue Type +	Ma	Location *	CR
Category	Earthen Levee			GPS Latitude/Longitude	
				Start	End
Item	Crown Surface / Depressions / Rutting			38.363101 °	38.363101 °
				-121.557847 °	-121.557847 °
DWR ID	DWR_RD0150_03_f_2012_91				
Action/Comments					
Add appropriate gravel or road base. Grade and compact.

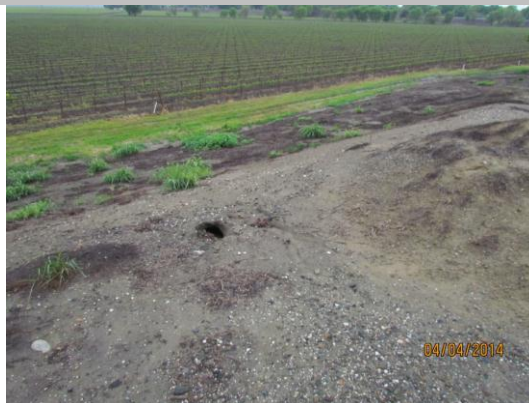
Photo 1 of 3 : pkazi\_s\_20140404\_075.jpg

Updated view of the rodent hole on the landside shoulder of the levee during spring 2014 inspection.

LM Start	3.34	Rating **	M	Issue No.	70
LM End	3.34	Issue Type +	Ma	Location *	LS
Category	Earthen Levee			GPS Latitude/Longitude	
				Start	End
Item	Animal Control			38.363015 °	38.363015 °
				-121.557325 °	-121.557325 °
DWR ID	DWR_RD0150_03_s_2012_70				
Action/Comments					
No rodents visible, but rodent burrows visible; need to backfill and compact or grout burrows.

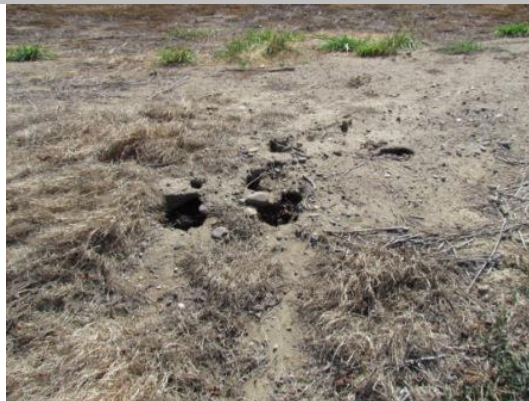
Photo 2 of 3 : pkazi\_s\_20140328\_675.jpg

Animal holes were found on the landside shoulder of the levee. This picture was taken from the crown looking towards the landside of the levee during fall 2012 inspection.

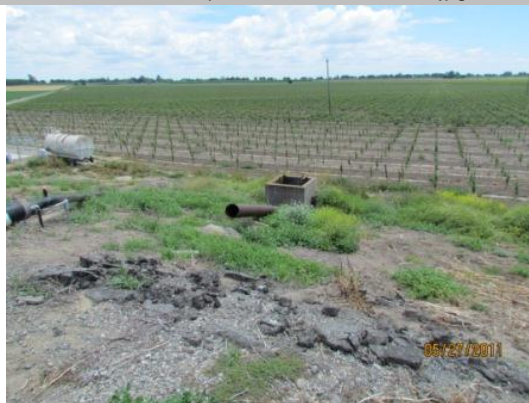
Photo 1 of 1 : pkazi\_s\_20140328\_638.jpg

LM Start	3.34	Rating **	M	Issue No.	39
LM End	3.34	Issue Type +	En	Location *	LS
Category	Earthen Levee			GPS Latitude/Longitude	
				Start	End
Item	Encroachments			38.363043 °	38.363043 °
				-121.557316 °	-121.557316 °
DWR ID	DWR_RD0150_03_s _ 2012_39				
Action/Comments					
Pipe

An abandoned pipe was located on the landside of the levee. The picture was taken from the crown looking downstream.

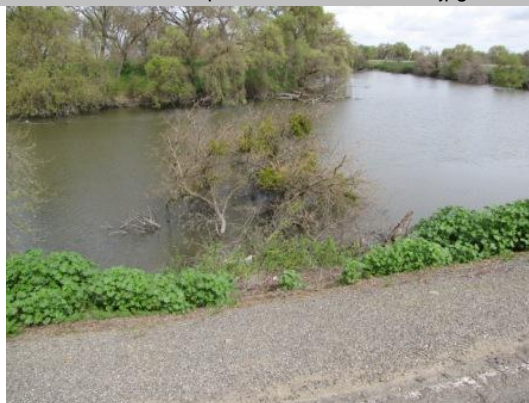
Photo 1 of 1 : pkazi\_s\_20140328\_627.jpg

LM Start	3.41	Rating **	N	Issue No.	27
LM End	3.41	Issue Type +	Ma	Location *	WS
Category	Earthen Levee			GPS Latitude/Longitude	
				Start	End
Item	Trim / Thin Trees			38.363147 °	38.363147 °
				-121.556190 °	-121.556190 °
DWR ID	DWR_RD0150_03_s_2012_27				
Action/Comments					
Tree stumps.

View of tree stumps on the waterside slope looking upstream.

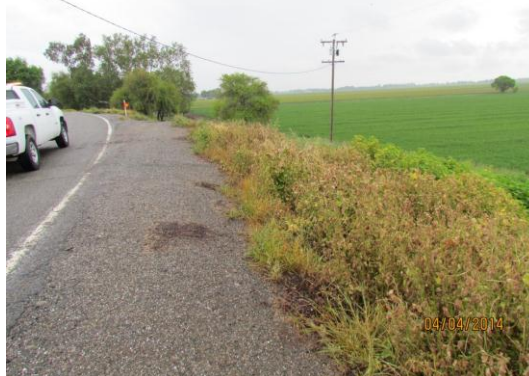
Photo 1 of 1 : pkazi\_s\_20140404\_076.jpg

View of the vegetation on the landside of the levee looking upstream.

LM Start	3.45	Rating **	M	Issue No.	74
LM End	3.54	Issue Type +	Ma	Location *	LS
Category	Earthen Levee			GPS Latitude/Longitude	
				Start	End
Item	Vegetation			38.363565 °	38.364704 °
				-121.555543 °	-121.555364 °
DWR ID	DWR_RD0150_03_s_2014_74				
Action/Comments					
Control annual grass and weeds on the levee slopes and easements.

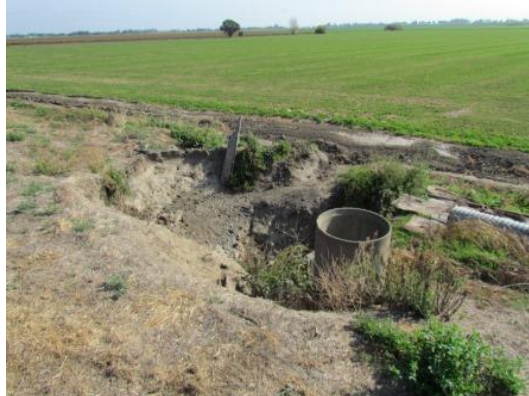
Photo 1 of 1 : pkazi\_s\_20140328\_696.jpg

LM Start	3.45	Rating **	U	Issue No.	115
LM End	3.45	Issue Type +	Ma	Location *	LS
Category	Earthen Levee			GPS Latitude/Longitude	
				Start	End
Item	Erosion / Bank Caving			38.363540 °	38.363540 °
				-121.555554 °	-121.555554 °
DWR ID	DWR_RD0150_03_f_2013_115				
Action/Comments					
Schedule repair of erosion site prior to the next inspection. Inspector Comments: Erosion was found on the landside toe of the levee.

A drainage ditch with depth of 4 feet and width of 15 feet was found on the landside toe of the levee. The picture was taken from the landside slope looking upstream during the fall 2013 inspection.

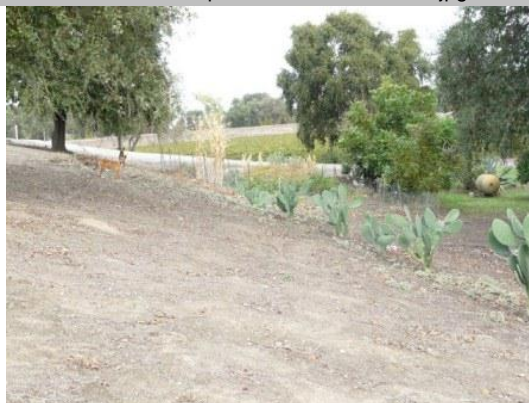
Photo 1 of 1 : pkazi\_s\_20140328\_643.jpg

LM Start	3.50	Rating **	M	Issue No.	47
LM End	3.54	Issue Type +	En	Location *	LS
Category	Earthen Levee			GPS Latitude/Longitude	
				Start	End
Item	Vegetation			38.364251 °	38.364772 °
				-121.555321 °	-121.555343 °
DWR ID	DWR_RD0150_03_s _ 2012_47				
Action/Comments					
Landscaping

Landscaping & garden on landward slope of levee at LM 3.50 to LM 3.54.

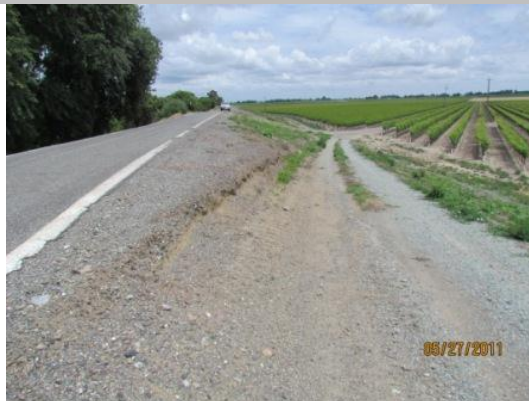
Photo 2 of 2 : pkazi\_s\_20140328\_702.jpg

Slope instability possible due to vehicular traffic on the landside of the levee. The picture was taken from the crown looking upstream during Spring 2011 inspection.

LM Start	3.75	Rating **	A/W	Issue No.	927 (cont)
LM End	3.75	Issue Type +	Ma	Location *	LS
Category	Earthen Levee			GPS Latitude/Longitude	
				Start	End
Item	Slope Stability			38.367305 °	38.367305 °
				-121.554984 °	-121.554984 °
DWR ID	DWR_RD0150_03_s_2012_927				
Action/Comments					
Repair the levee slope damaged by vehicle traffic and prevent access where possible.

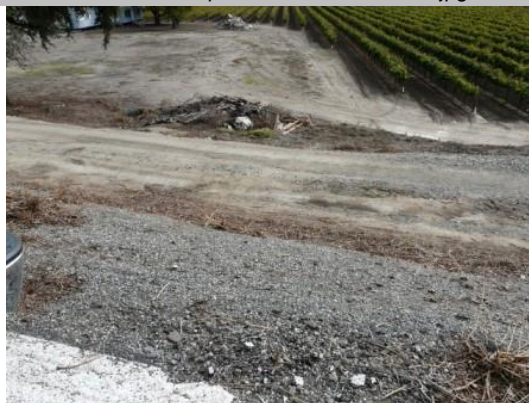
Photo 1 of 3 : pkazi\_s\_20140328\_644.jpg

LM Start	3.95	Rating **	M	Issue No.	48
LM End	3.95	Issue Type +	Ma	Location *	LS
Category	Earthen Levee			GPS Latitude/Longitude	
				Start	End
Item	Encroachments			38.368118 °	38.368118 °
				-121.551509 °	-121.551509 °
DWR ID	DWR_RD0150_03_s_2012_48				
Action/Comments					
Debris

Debris pile on landward slope at LM 3.95.

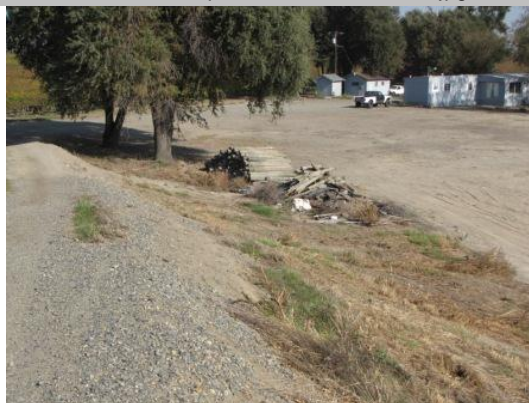
Photo 2 of 3 : pkazi\_s\_20140328\_645.jpg

Updated view of material piled at the toe of the levee as of fall 2009.

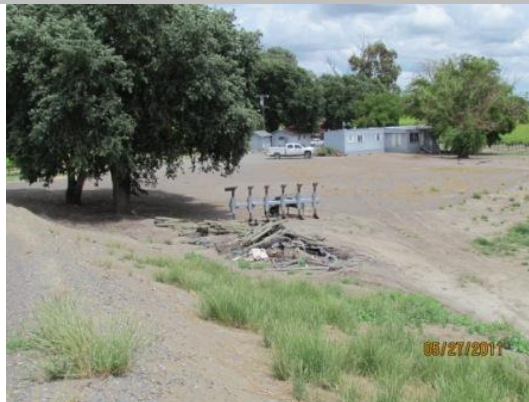
Photo 3 of 3 : pkazi\_s\_20140328\_646.jpg

Debris found on the landside of the levee during Spring 2011 inspection.  
The picture was taken from the crown looking upstream.
